# F-24 MK II BEAM TOP INNER END REPAIR

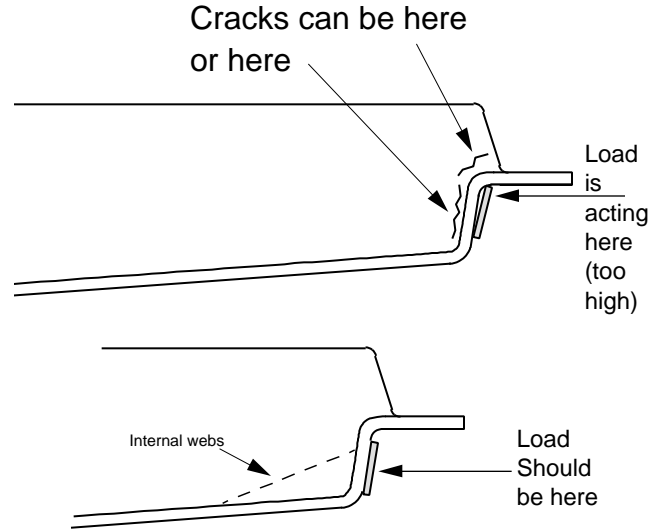
Some F-24 Fwd. Beams have developed cracks in the area shown. These are not considered to be a serious threat to the structural integrity of the beam but should be repaired as shown.

The upper cracks are usually caused by the compression pads being fitted too high creating a point load just under the horizontal flange, or misaligned beams/pads. Once this is corrected, then upper crack can be a normal surface gelcoat repair, with a little glass added to reinforce.

4. Check that compression pad on beam bears evenly against hull pads. Bearing on top edge only or just one corner can cause the cracks
