Megawat's last hour - 28/5/05

Philip Watson describes the sinking of his boat, *Megawat*

Photos taken from yacht *Quite Correct*

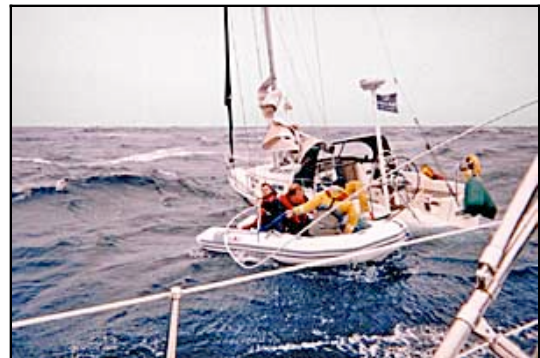
Minus 11 minutes

When I next went below it was to discover an unwelcome development. Water was well over the floorboards, and shoes etc, were floating about. Time to radio the Coastguard again, and reveal the worsening situation. They confirmed having scrambled two lifeboats and a helicopter. At about this time I spotted our rudder, with about half its stock attached, floating away from us.

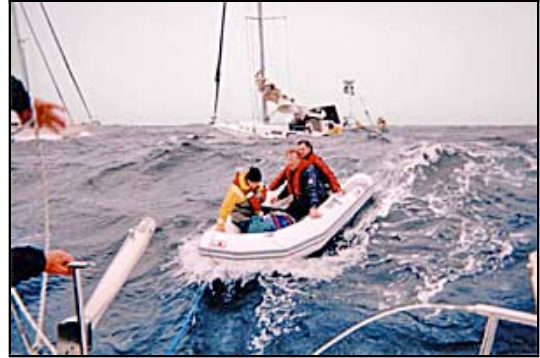
**Minus 10 minutes**

Water was now almost level with the companionway and we were eager (if at all possible) to have a dry transfer to the larger yacht, so we hailed them to launch their own dinghy, which was fully inflated on the foredeck. It's a RIB, about 11 feet long, so it took four crew to lift it over the rails, but they did it perfectly. They streamed it downwind to us on a long painter, and we were mightily relieved to get into it without the need for a spell in the cold water. We each brought a kitbag of gear, but inevitably, not the gear one would have chosen if you had an extra hour to consider it!
